Walking on water

The famous Sandon flume and the "flood" of '55

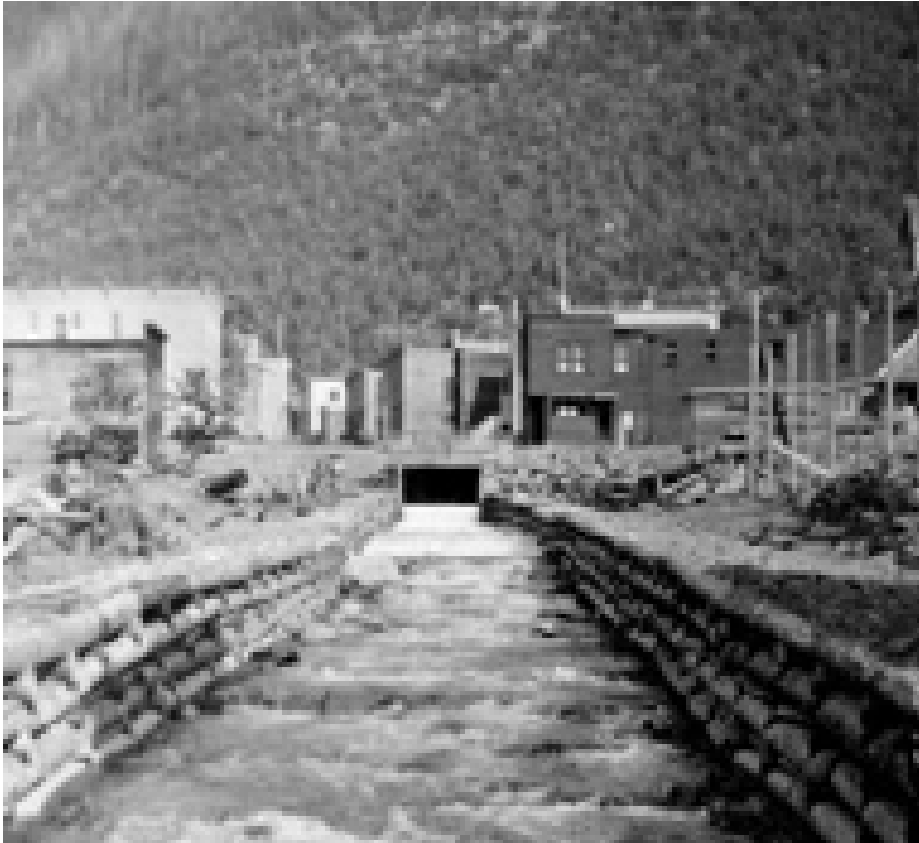
At 14 feet wide and eight feet deep (4.26 by 2.43 metres), the final cost of the flume was \$15,000. The inlet was located beside the K&S trestle; downstream, just below the present Silversmith Powerhouse, the flume took a 90 degree turn, and was joined by the Sandon Creek flume at a point near the CPR station house. Below this point, the main flume took a 45 degree turn and followed a straight line through the city, passing directly in front of the current Sandon Historical Society Museum and continuing as far as the present bridge over Carpenter Creek.

From the CPR station house to the outlet point, the flume was then planked over and became a third street on the bottom of the valley floor. On each side of the street there was also a wide boardwalk. It was after the fire of 1900 that the decision was made to relocate the city's main street from Reco Avenue to the planked-over flume, which was renamed Main Street. Indeed, in pictures following the fire, the scorched top of the flume can clearly be seen. For 55 years the strange construction served its dual purpose as a flume and a street, and it became famous far and wide. Problems were soon to develop, however.

From an engineer's perspective, the flume was a disaster waiting to happen. It was far too narrow to handle the volume of water that passed through it, particularly during the spring thaw. At the points where it made a sharp bend, or where the Sandon Creek flume joined it, the main flume was subject to tremendous strain from the rushing water, as well as providing the perfect "trap" for logs and debris which washed downstream during periods of high water. In the straight section of the flume, the rushing water reached speeds of up to 60 miles an hour (96.54 km per hour), with the result that a loose plank could cause a major catastrophe within minutes. In constant need of maintenance, the flume soon became an ongoing headache. In 1928, the 30-year-old flume underwent extensive repairs, at a cost of \$15,000 - the same as the original cost of construction.
